REGISTERED PROFESSIONAL SURVEYORS  
**HERBERT S. BEASLEY**  
**LAND SURVEYORS L.P.**  
• LAND • TOPOGRAPHIC  
• CONSTRUCTION SURVEYING  
FIRM NO. 10094900  
METRO 817-429-0194  
FAX 817-446-5488  
hsbeasley@msn.com  
P. O. BOX 8873  
FORT WORTH, TEXAS 76124

Surveyed on the Ground  
December 22, 2020

boundary, Topographic,  
& Tree Survey of  
2.276 acres of land  
located in the  
Thomas Freeman Survey  
Abstract No. 453  
City of Hutchins  
Dallas County, Texas

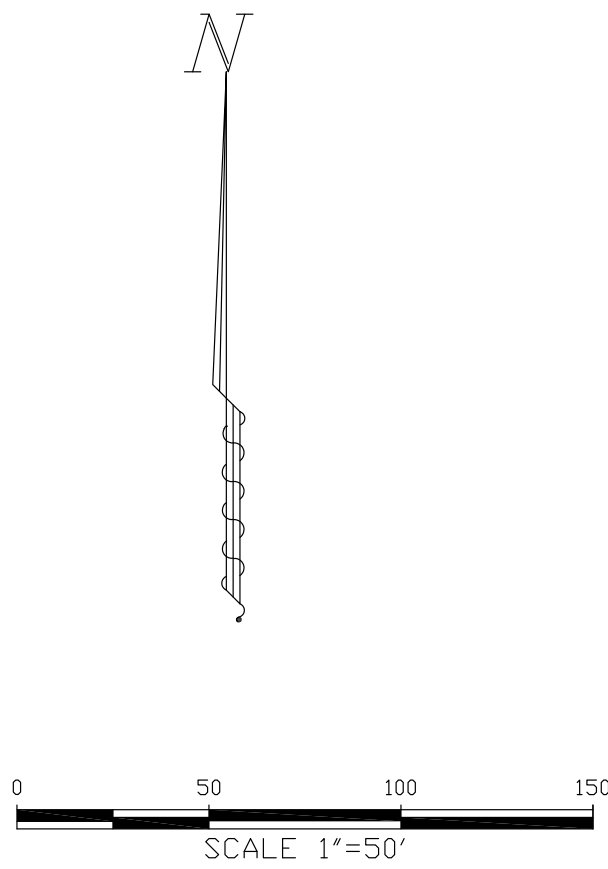
Being 2.276 acres of land located in the Thomas Freeman Survey, Abstract No. 453, Dallas County, Texas, being the tract of land described in the deed to Commercial State Bank, recorded in County Clerk's Instrument No. 202000283658, Deed Records, Dallas County, Texas. Said 2.276 acres of land being more particularly described as follows:

BEGINNING at a mag nail found in asphalt at the southwest corner of said Commercial State Bank tract;

THENCE N30°51'31"W, along the west line of said Commercial State Bank tract, a distance of 331.96 feet to a point in a ditch at the northwest corner of said Commercial State Bank tract, being the southwest corner of a tract of land described in the deed to Kamy Real Property Trust, recorded in Instrument No. 201400183054, Deed Records, Dallas County, Texas;

THENCE along the north line of said Commercial State Bank tract and the south line of said Kamy Real Property Trust tract as follows:

- N49°47'35"E, a distance of 116.93 feet to a point in a ditch;
  - N32°39'32"E, a distance of 173.09 feet to an X cut found at the northeast corner of said Commercial State Bank tract and at the southeast corner of said Kamy Real Property Trust tract;
- THENCE along the east line of said Commercial State Bank tract as follows:
- S35°29'21"E, a distance of 168.05 feet to a 1/2" iron rod found;
  - S23°46'34"E, a distance of 214.58 feet to a 1/2" iron rod found at the most easterly southeast corner of said Commercial State Bank tract;
  - S18°16'53"W, a distance of 74.77 feet to a 1/2" iron rod found at the most southerly southeast corner of said Commercial State Bank tract;

THENCE S59°29'32"W, along the south line of said Commercial State Bank tract, a distance of 200.86 feet to the point of beginning, containing 2.276 acres of land.
